Master Plan Report

Millbrook Meadow and Mill Pond Restoration

January 2015

Rockport, Massachusetts

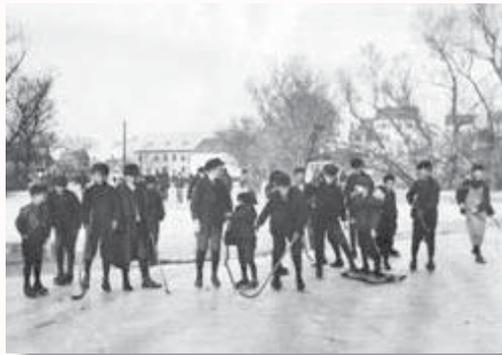
Image from: "A Plan of the Old Mill Pond Property on Davidson's Brook", Rockport, Mass, Owned by C.J. Norwood

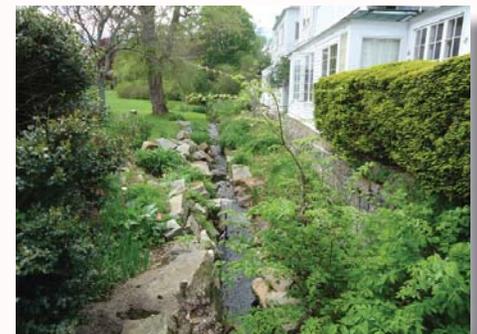
- The Mill Brook Channel flows north from the dam spillway and travels northwest through a heavily stone-lined channel, then through the adjacent parcel (#320 and #320A) and discharges into the Frog Pond. From the Frog Pond, Mill Brook is conveyed within a straight granite block-lined channel, partially crumbling, northeast to Beach Street, passing below Beach Street via the Beach Street culvert and onto Front Beach. Three pedestrian bridges located adjacent to the Frog Pond cross over the Mill Brook channel.

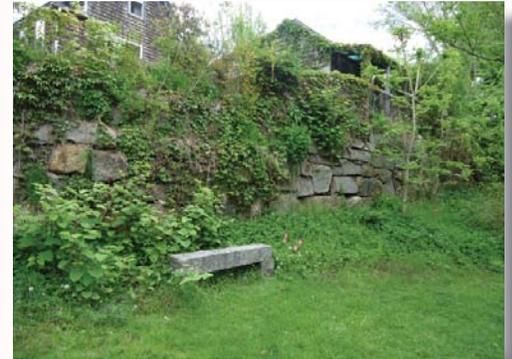
Existing Stone Walls

- Stone walls of varying heights are found throughout the site and show signs deterioration. Some of these walls retain grades along King Street others are freestanding. Refer to the Preliminary Structures Inspection Report in the Appendix for additional information. Stone retaining walls, some of which show significant deterioration, retain grades along the western edge of the Mill Pond, and a significant wall collapse is occurring upstream of the Beach Street culvert.
- Three large Weeping Willows (*Salix babylonica*) are present in the meadow and are in poor health due to the age of the trees (i.e., 75 to 100 years).
- A slide and swing set sits on the eastern edge of the meadow, and benches are placed sporadically throughout the meadow.

Of the stone wall structures investigated, dry-stacked stone walls 2, 6 and 9 were identified as being in the poorest of conditions. Wall 2 is located just upstream of the Beach Street culvert and is falling into the Mill Brook and impeding flows into the culvert by constricting the upstream invert of the culvert. Wall 6 ranges in height from +/-6'-0" to +/-10'-0" and was found to be overgrown with vegetation, missing various stones, and leaning/overturning in multiple locations. Stones should be replaced and re-laid as necessary. Wall 9 is +/- 3'-0" in height and was found to be overturning with visible signs of a sinkhole. Stones should be replaced and re-laid and the sinkhole repaired as necessary.

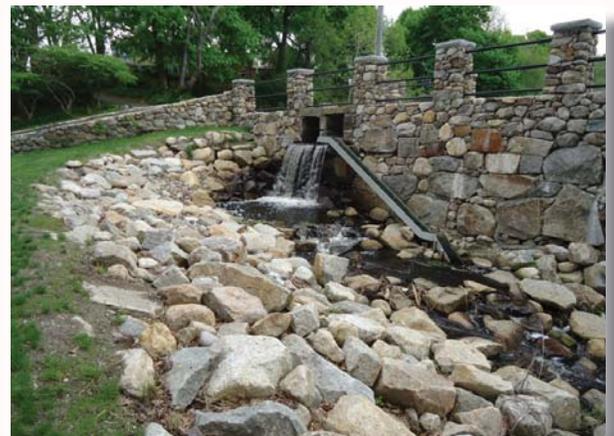
Mill Pond Dam

- The Dam, which creates the Mill Pond impoundment, was reconstructed in 2010. The dam spillway is comprised of two box culverts on its southeastern end. The top of the dam is a mixture of a flat fieldstone/stone dust walkway with raised fieldstone columns with granite column caps. Steel pipe safety railings extend 42" above the dam and are located between the columns. Fieldstone vertical walls face the north side of the dam.

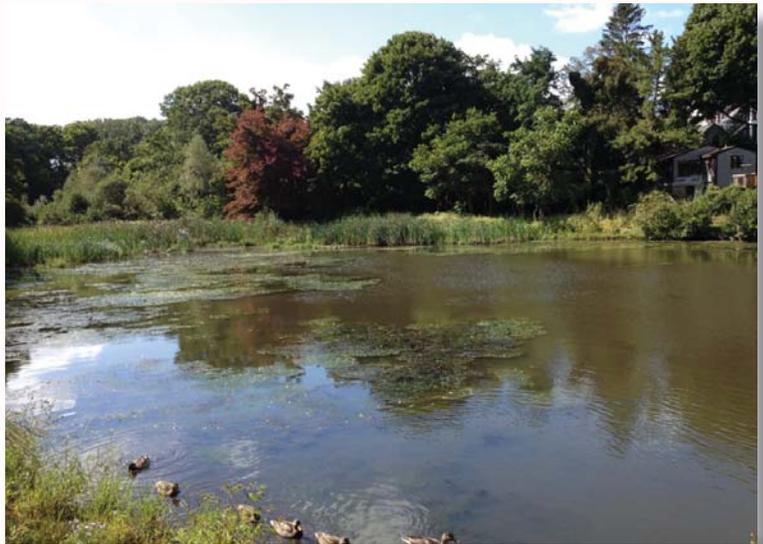
- The Mill Pond is a shallow open water body impoundment that currently has approximately $\frac{3}{4}$ of an acre of open water. The pond has been slowly filling with sediments from Mill Brook and reducing the open water areas. Open water depths range from a few feet at the edge to approximately 4 feet within the center portions of the pond. The open water areas have decreased significantly over the past 80 years (based on review of historical aerials and maps-see Appendix). The central portion of the pond has a sediment delta that has become heavily vegetated with broad leaved cattails. The east, west, and northern edges of the pond are lined with varying sizes of granite blocks that are beginning to buckle, most likely due to the freeze/thaw process. The eastern and western sides of the pond are a mix of lawn and non-native invasive vegetation, some of which has been recently removed. Invasive vegetation including multiflora rose (*Rosa multiflora*), wild grape (*Vipes sp.*), porcelain berry (*Ampelopsis brevipedunculata*), Japanese knotweed (*Fallopia japonica*), and oriental bittersweet (*Celastrus orbiculatus*) have become prevalent along the shoreline. Accessibility to the pond has become increasingly limited by shoreline/riparian vegetation overgrowth and deterioration of former granite access steps. A recent woodchip path has been installed by the Boy Scouts on the eastern edge of the pond that leads up the edge of the Union Cemetery.

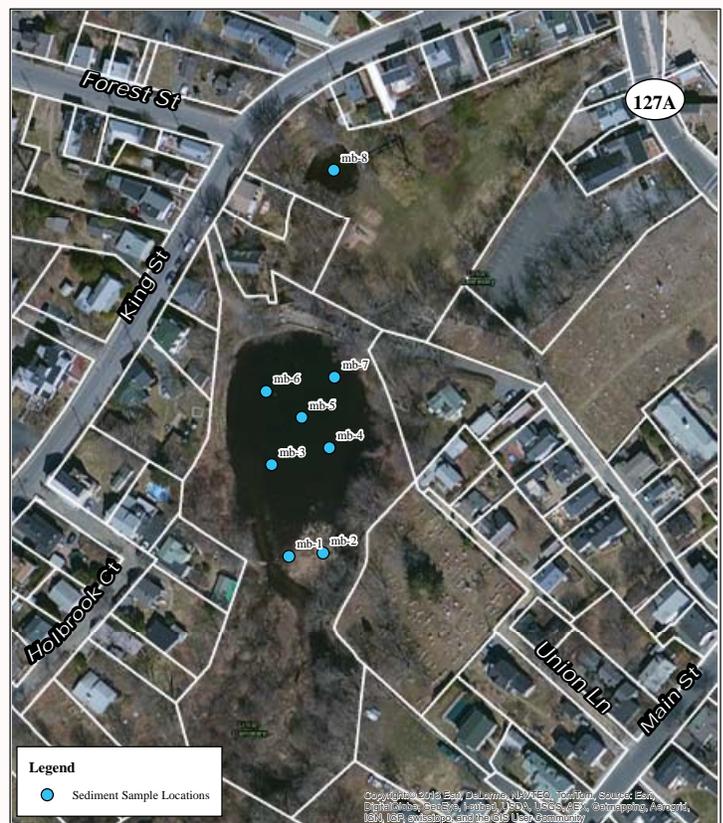
Sediment Sampling Locations

Based on PEER’s findings within the ESA, PEER and MMI completed sediment sampling from within the Mill Pond and Frog Pond to assess the levels of contamination within the sediments. Understanding the contaminant levels within the underlying sediment is important for the future dredging design, special sediment handling, and disposal options. Specific grab sediment samples were collected from within Mill Pond and Frog Pond (MB-1 through MB-8 (see map previous page)). The sediment samples were analyzed for metals, PAHs, PCBs, EPHs, and grain size. The Mill Pond sediments consist primarily of silt sediments, and the Frog Pond consists primarily of sandy sediments.

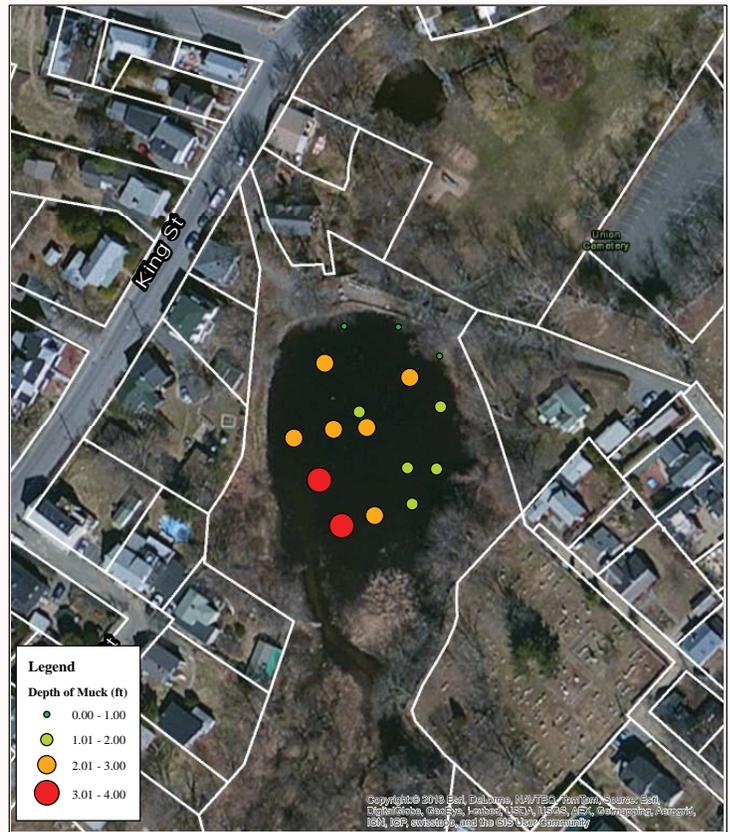
Sediment Probe Depths

Based on the sediment sampling, the Mill Pond is made up of 80-90% silt, while the Frog Pond is made up of 75% sand. The sediments within both ponds contained concentrations of contaminants in the sediment that did not exceed MADEP Policy #COMM-97-001 for acceptance and use at a Massachusetts lined landfill. Of the analytes sampled within the eight sediment sample locations, only one contaminant, lead, was detected at a concentration above the MCP RCS-1 reporting concentration (200 mg/kg). Lead concentrations in sediment exceeded the RCS-1 standard in seven of eight sample locations and ranged in concentration from 255 mg/kg to 583 mg/kg at these seven locations.

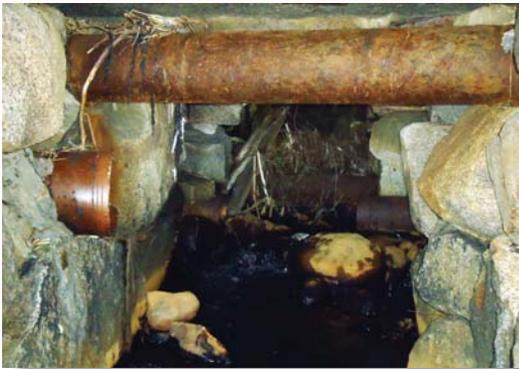
Existing Utilities & Debris Clogging within Beach Street Culvert

22. Existing perennial gardens are high maintenance, and this type of garden is only found in this location.
23. No formal park gateway
24. Utility pipes within culvert and rough irregular granite blocks increase debris clogging, reduce hydraulic capacity, and increase DPW maintenance

Falling stones, utility pipes (some of which may be abandoned), and a curved longitudinal profile contribute to debris clogging inside and upstream of the culvert. As a Phase I approach, investigate cutting and capping any utilities and resetting/repointing stones within the culvert. If clogging is still an issue, consider investigation of full culvert replacement.

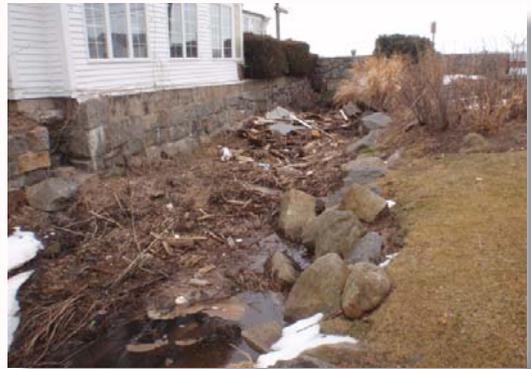
Debris Clogging from Flooding within Mill Brook Channel Upstream of Beach Street Culvert

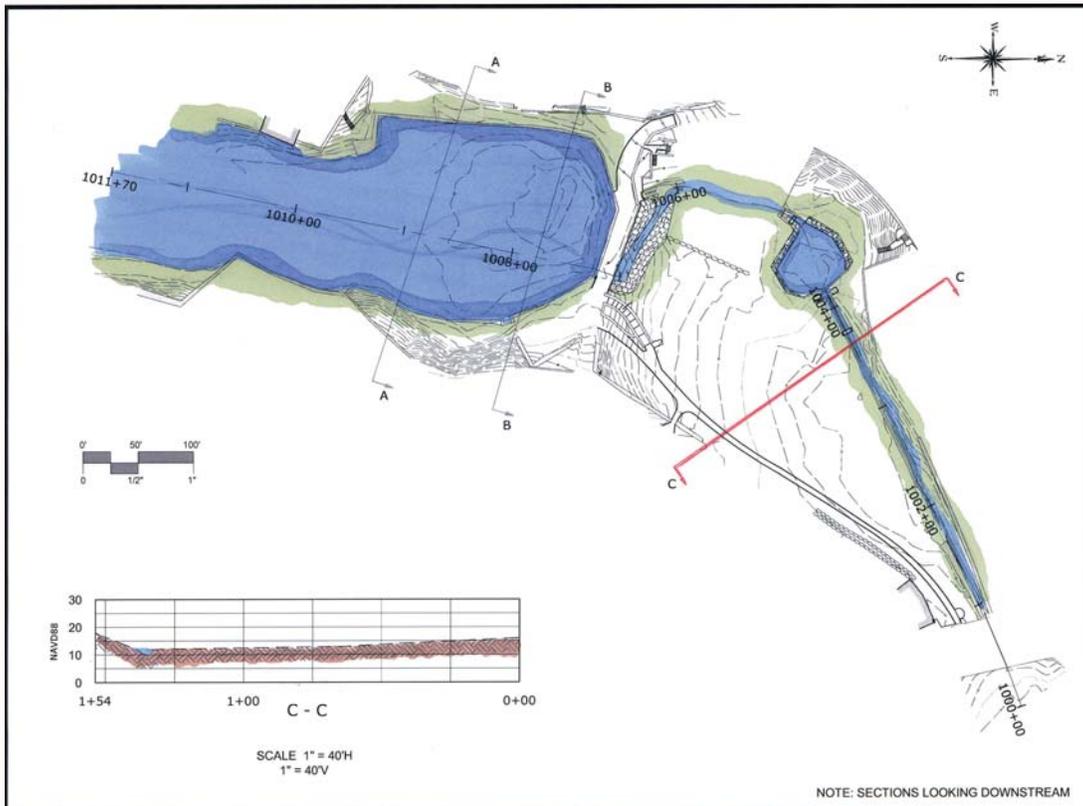
Existing Cross Section of Mill Brook Channel

Our preliminary findings indicate that increasing the width of the Mill Brook channel between the Frog Pond and Beach Street culvert decreases nuisance flooding within the park. Increasing channel width will also allow for creation of increased habitat structures, including pools and riffles. Widening the span of the Beach Street culvert to 10 feet can alleviate frequent flooding but will not significantly impact larger storm events. A culvert span of 15 feet is required to achieve the Massachusetts recommended design guidelines for culverts based on the 25-year storm event predicted by GEI. Reducing debris clogging of the culvert does have a significant impact on nuisance flooding within the park. The culvert is undersized for its recommended design storm of 15 years. The small span also exacerbates debris clogging. The Frog Pond weir/footbridge has a capacity of 70 cfs. During flows greater than this, the park will flood from around the Frog Pond and not as a result of culvert capacity. Above 200 cfs, the park will flood from both Frog Pond as well as the culvert.

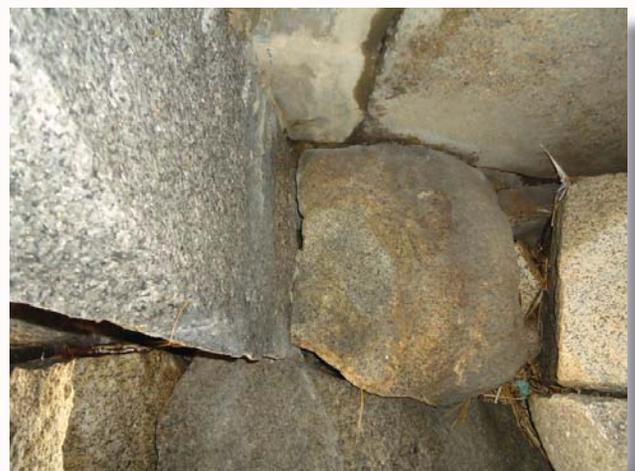
Loose Stone Condition within Beach Street Culvert

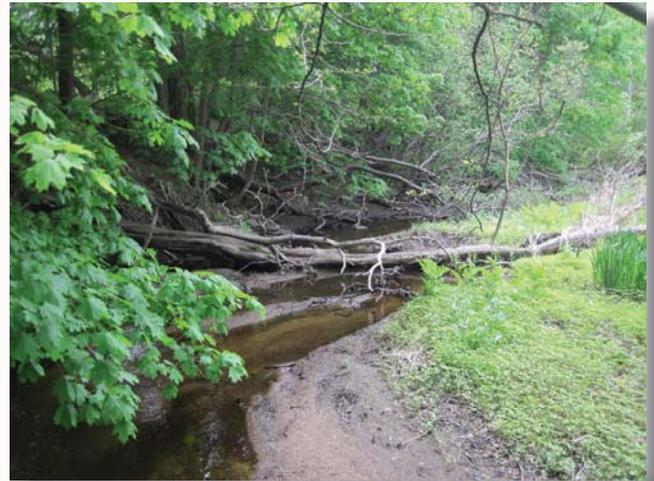
Typical Mill Brook Upstream Reach Condition

The Mill Brook channel varies in substrate conditions from its most upstream project limit (west of Mill Pond) downstream to its outlet at Beach Street culvert. As Mill Brook flows onto the Mill Brook Meadow property the watercourse has a width of approximately 12 feet and a substrate consisting of medium to coarse sands. The channel meanders as it discharges onto the Millbrook Meadow property and eventually flows north into Mill Pond. Large woody debris is present within the upper reaches of the brook within the project site. Small shallow pools are present. The brook has vegetated banks consisting of upland riparian zone vegetation and emergent marsh vegetation.

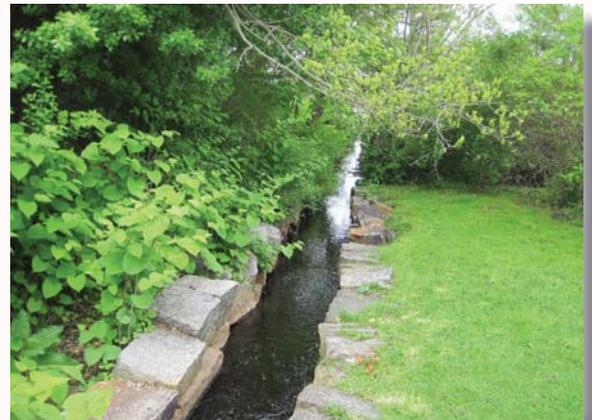
Typical Mill Brook Channel Condition Downstream of Frog Pond

Downstream of the Frog Pond, the Mill Brook channel width and substrate change significantly with the average watercourse width being approximately 4 feet wide, with granite lined banks, and a substrate consisting of stones and coarse sand. Vegetation along the banks includes Babylon willow, silky dogwood, Japanese knotweed, Common reed, and other herbaceous vegetation.

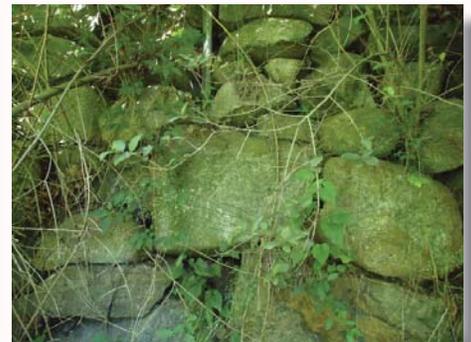
15. Deteriorating Stone Walls

15. Stone walls are in deteriorating shape from structural visual inspection.
16. Existing willow trees are approximately just under 100 years old. They have thrived due to the proximity of the water table as most weeping willows normally live about 50 years. Decay has advanced in both willow trees and will not last the next 10 years.

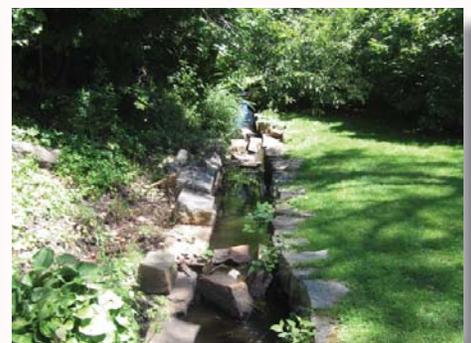
20. Granite Channel

20. Granite channel is narrow and straight limiting nooks and crannies for wildlife cover habitat. Granite blocks are falling into stream channel.
21. Commercial and residential facades of structures surrounding the park detract from this urban oasis and are unsightly.

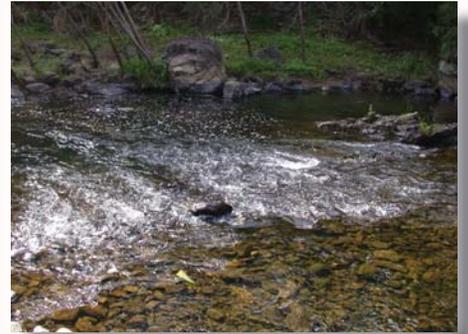
27. Riffle

27. Reconfigured channel with wide pools and narrow riffles (for smelt spawning and pedestrian crossing)

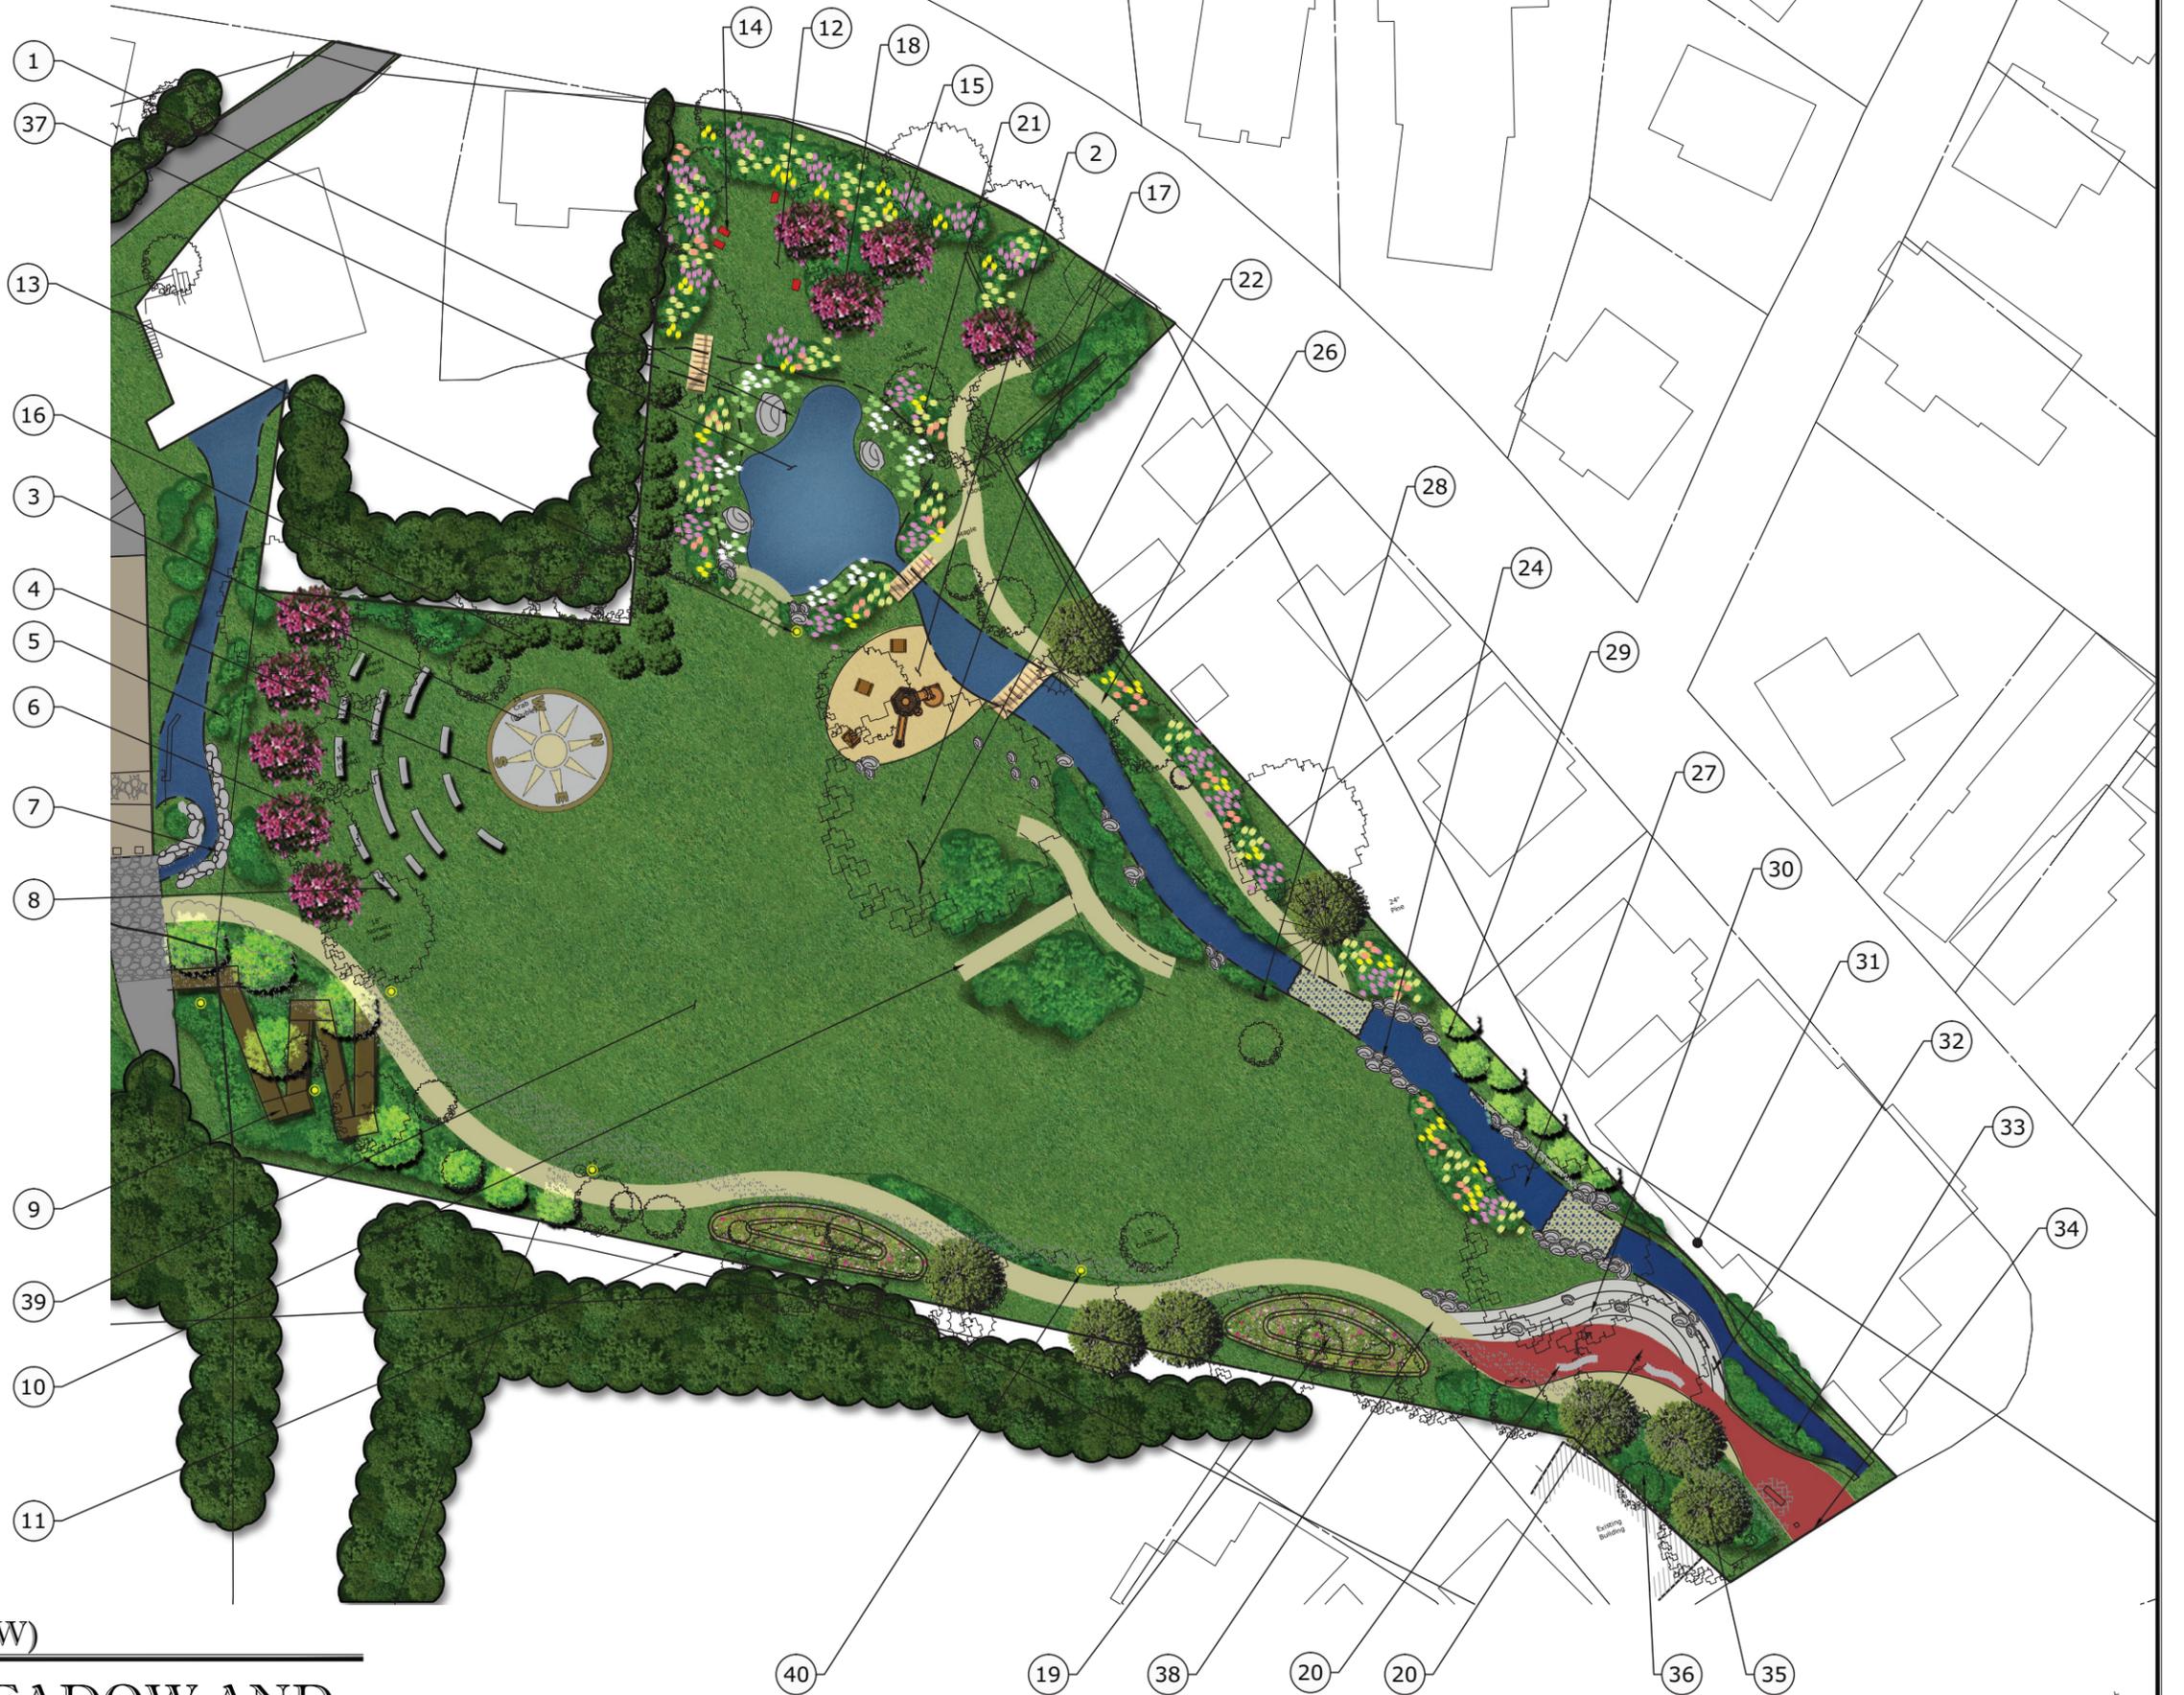
CONCEPT - 'A' (MEADOW)

- 34. Remove existing white fence and open up park entrance – install a steel silhouette entry sign with Millbrook logo
- 35. Nature-based sculptural element at entrance to park
- 36. Evergreen screening at entrance
- 37. Dredge the Frog Pond to 4'-0" depth
- 38. Permeable concrete walkway and granite pavers

- 39. Open lawn to remain
- 40. 12' ht. pole-mounted lighting

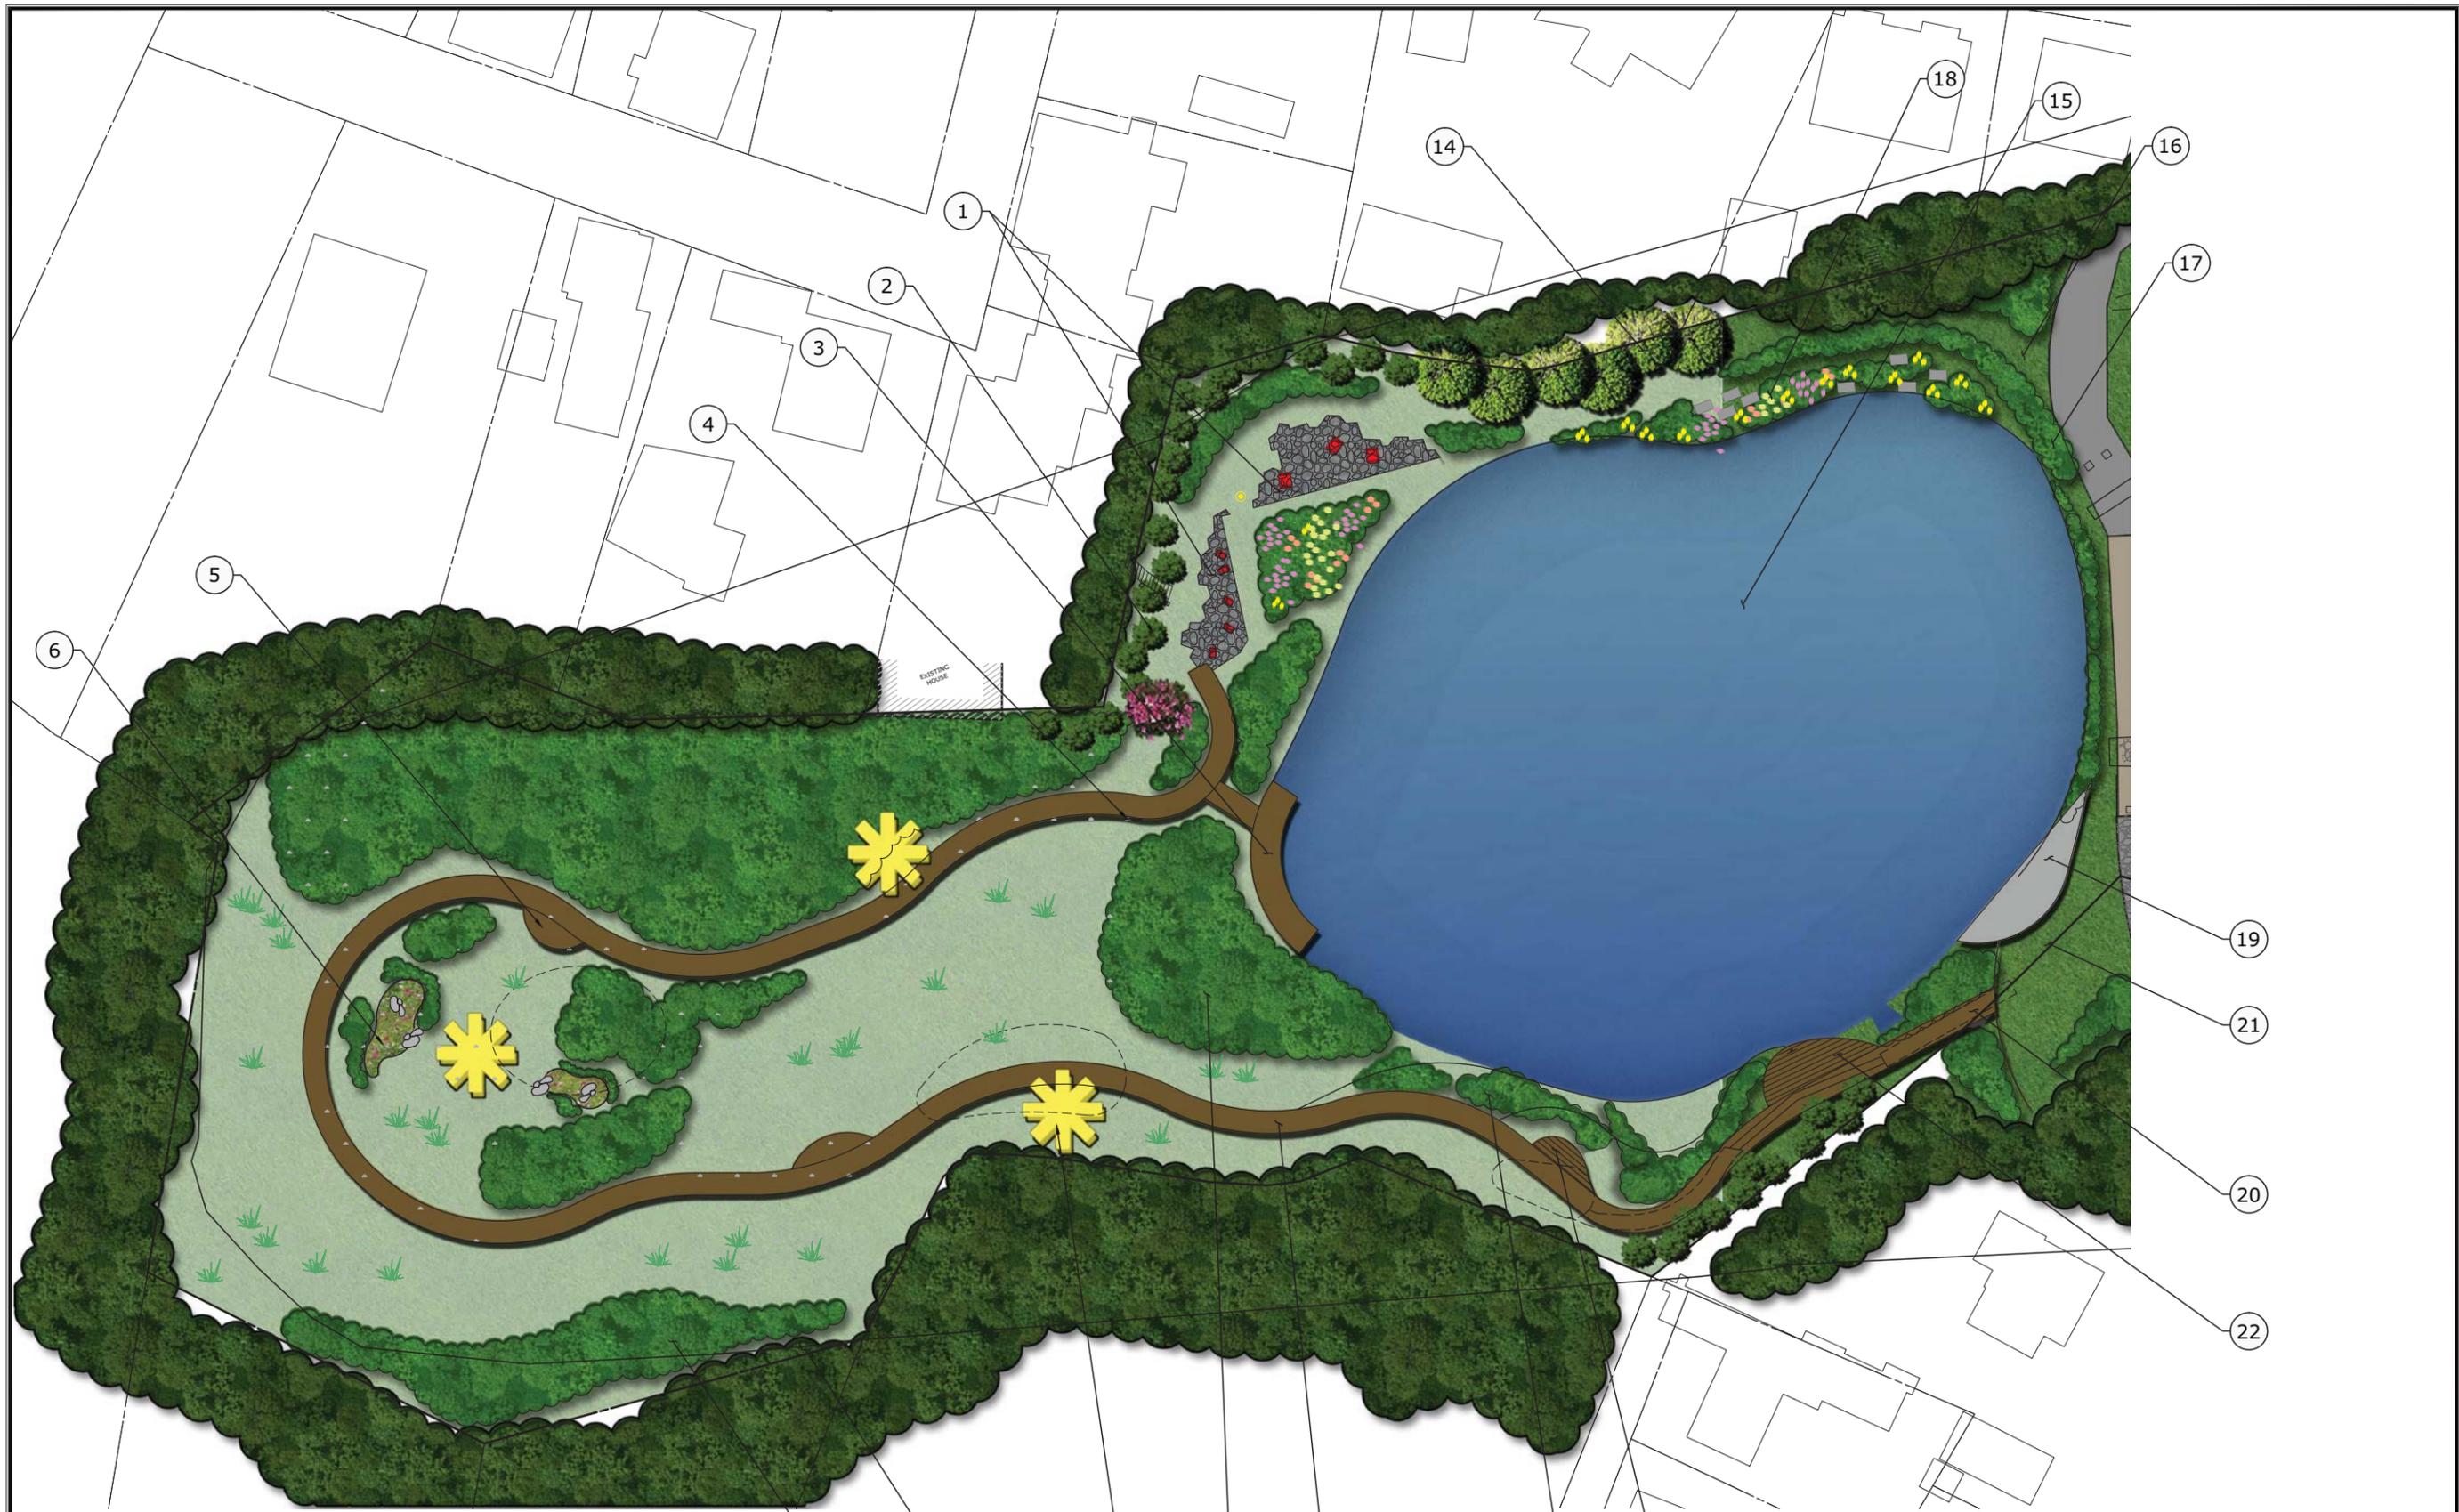
CONCEPT - 'A' (MILL POND)

1. Granite paver picnic area/overlook with granite pavers and Adirondack chairs
2. Evergreen screening
3. On-water fishing platform
4. Signage on boardwalk discusses the importance of cattails
5. Gathering spaces along boardwalk contain informational signage that discusses pond ecology and the benefits of dredging and wetland restoration
6. Habitat restoration features:
 - Depressional pockets with obligate species
 - Boulders
 - Sunning logs
7. New shade-tolerant wetland shrub plantings
8. Place bat boxes in existing Norway maple trees

9. Sculptural element placed in sandbank
10. Dredging of the Mill Pond eliminates 50% of the cattail population
11. Boardwalk follows watercourse
12. Spring ephemerals planted along trail (typ.)
13. Overlook area

14. Birch grove
15. Dredge Mill Pond to 8'-0" depth
16. Lawn or stone dust pathway (ADA accessible)
17. Perennial plantings along lawn walking path
18. Created littoral zone with granite blocks for stepping and seating
19. Granite block steps into water providing seating for ice skating
20. Mulched pathway
21. Open lawn to remain
22. Wood boardwalk and overlook area

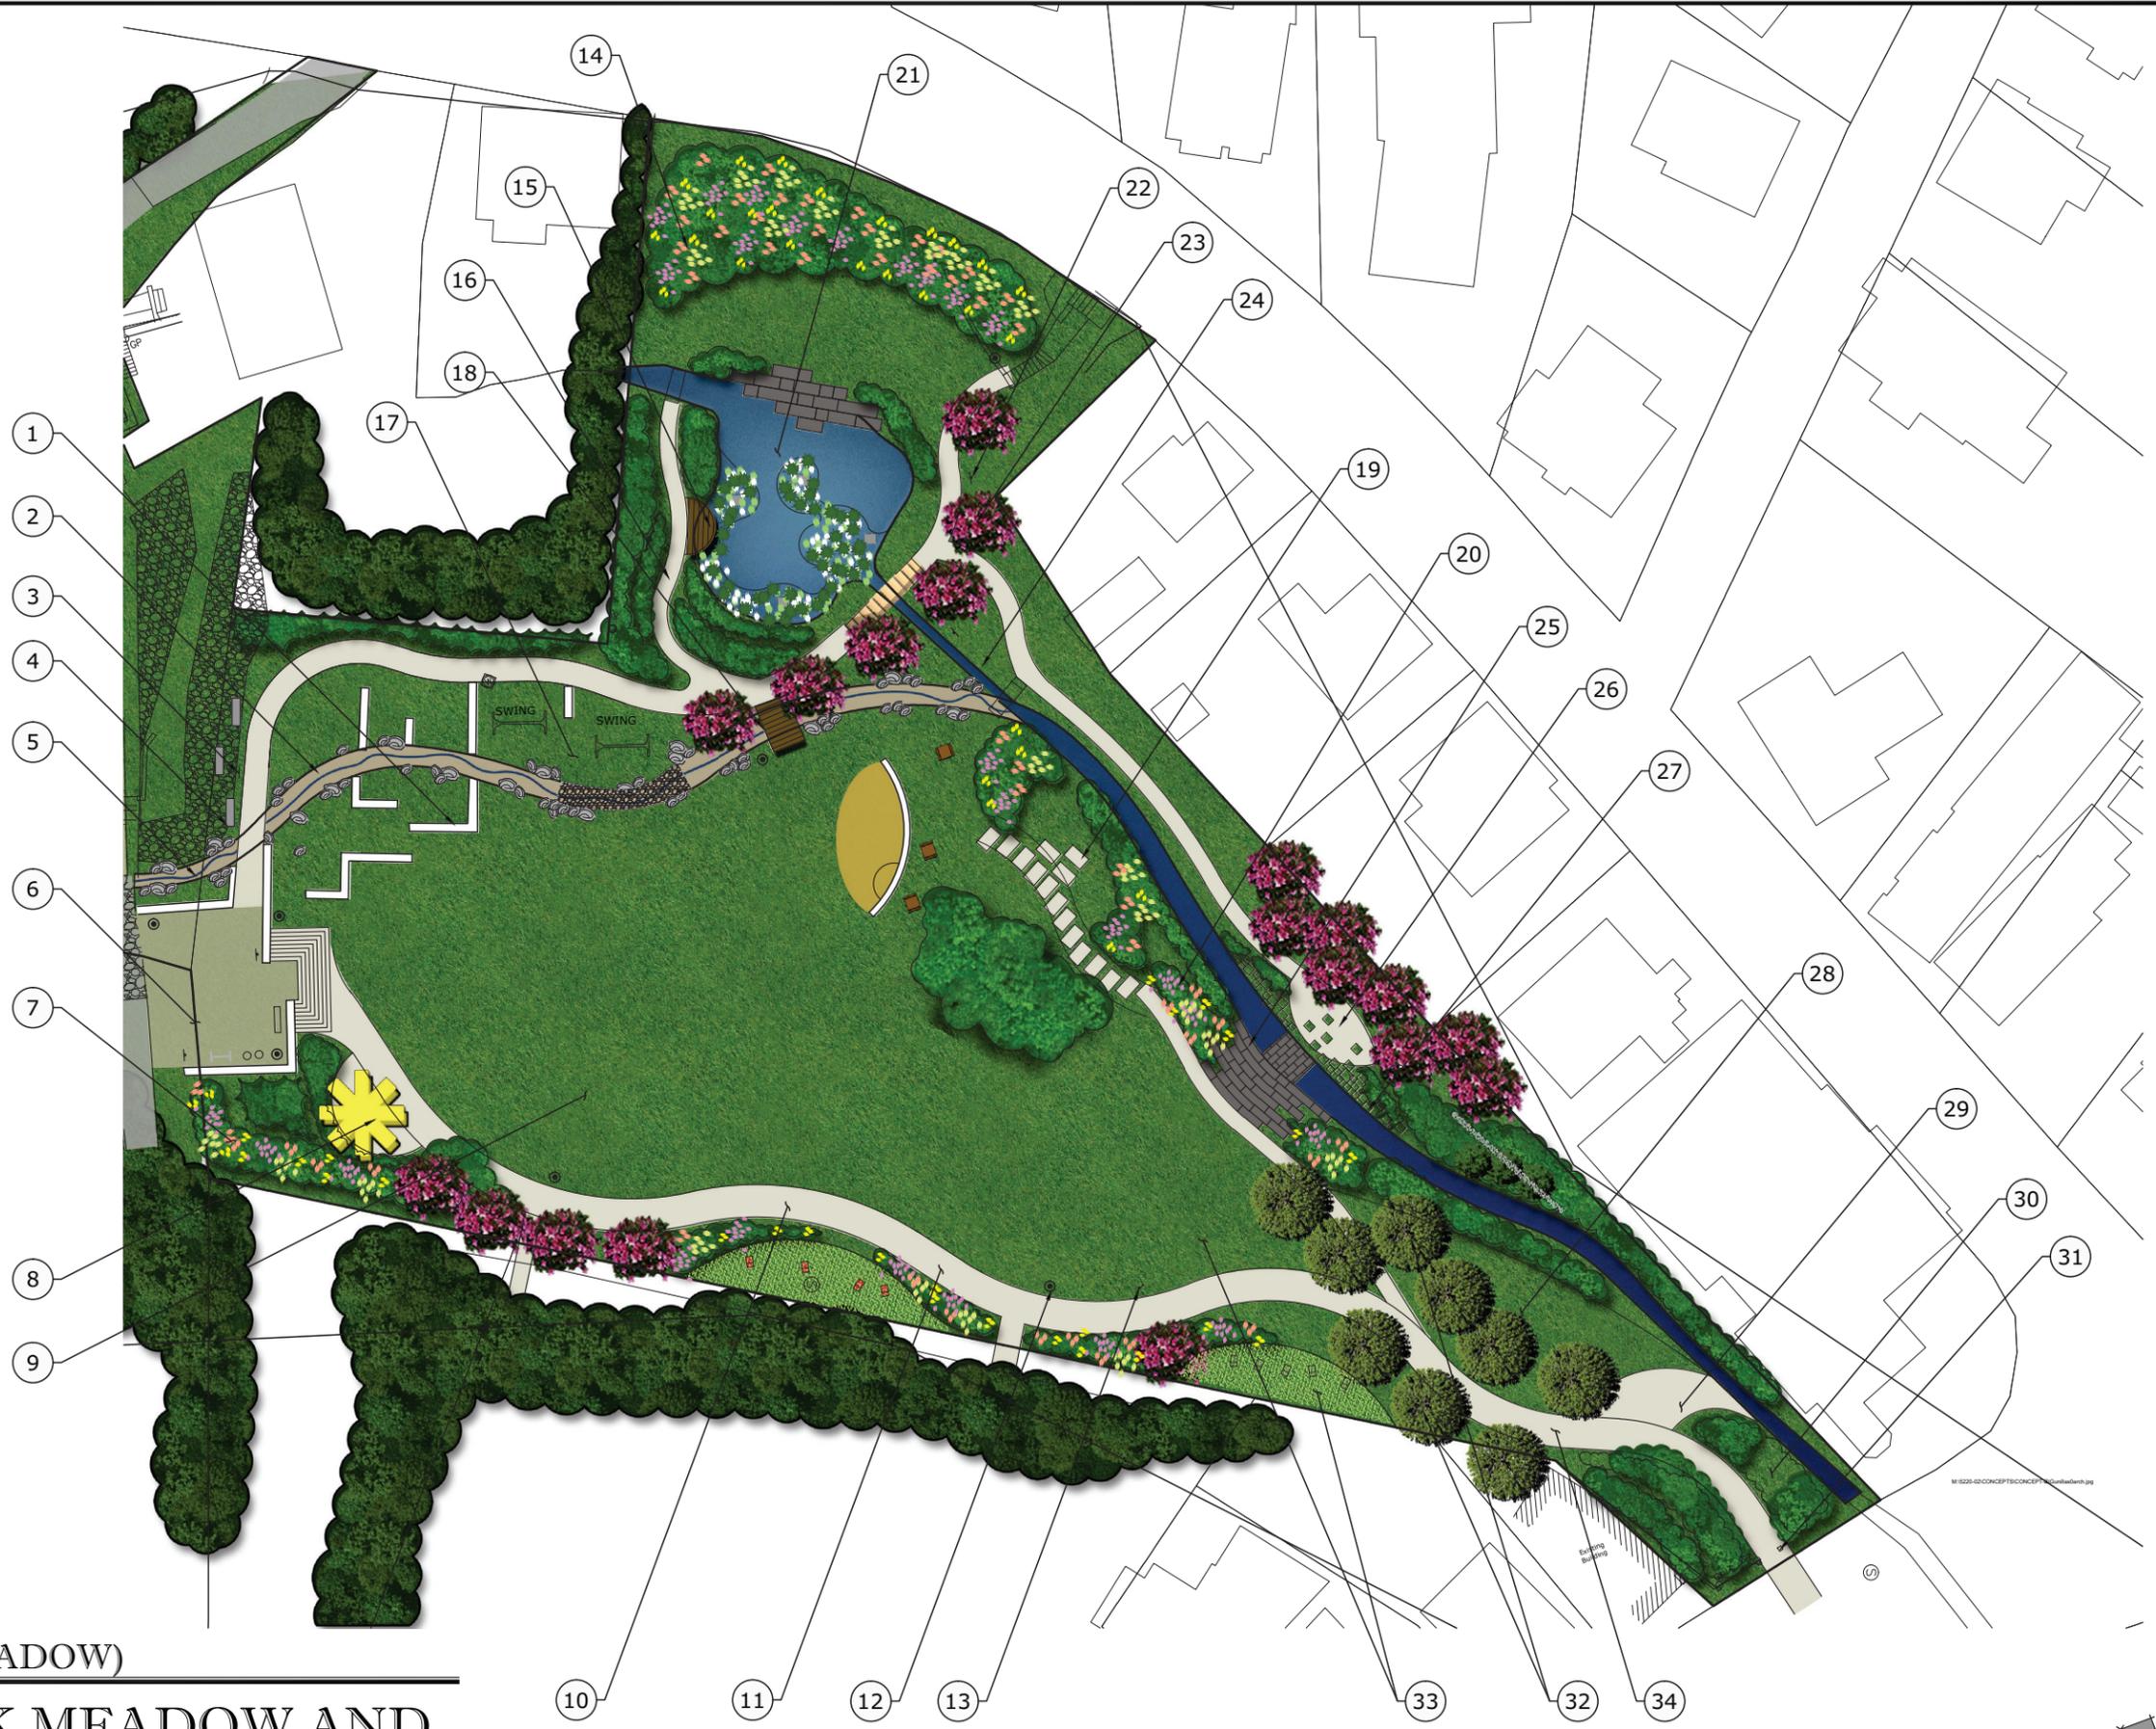
CONCEPT- 'B' (MEADOW)

1. Granite block “amphitheater”-style seating creates level picnic and viewing areas

2. Dry steam bed with anchor boulders planted with native sedges and ferns

3. Informational signage about dam reconstruction
4. Granite blocks seating placed along trail. Backless seating affords viewing of the spillway and meadow
5. Consider pumping water down created stream channel during special events
6. Overlook plaza:
 - New electric and water utilities
 - Historical signage re: Haskins Isinglass Factory
 - Bike rack
 - Trash/recycling
7. Cleanup existing woodland area and plant ferns and flowering perennials
8. Large industrial sculpture from Rockport’s history

23. Flowering dogwoods create aesthetic edge treatment along Frog Pond
24. Granite blocks to remain – provide signage illustrating history of straight channel

25. Granite block steps and seating to access stream channel

26. Destination location across stream channel with seating
27. Proposed granite blocks resemble pilings:
 - Engrave blocks with donor names
28. Lawn seating area
29. Compacted shell entry place
30. Garden club plantings to remain and expanded
31. Historic “Victorian” arch entry feature
32. Weeping willow tree allee along pathway. Willows uptake a lot of water – drying lawn area quicker
33. Lawn perches with lounge seating
34. Granite chip walkway or shell/concrete walk
