Master Plan Report

Millbrook Meadow and Mill Pond Restoration

January 2015

Rockport, Massachusetts

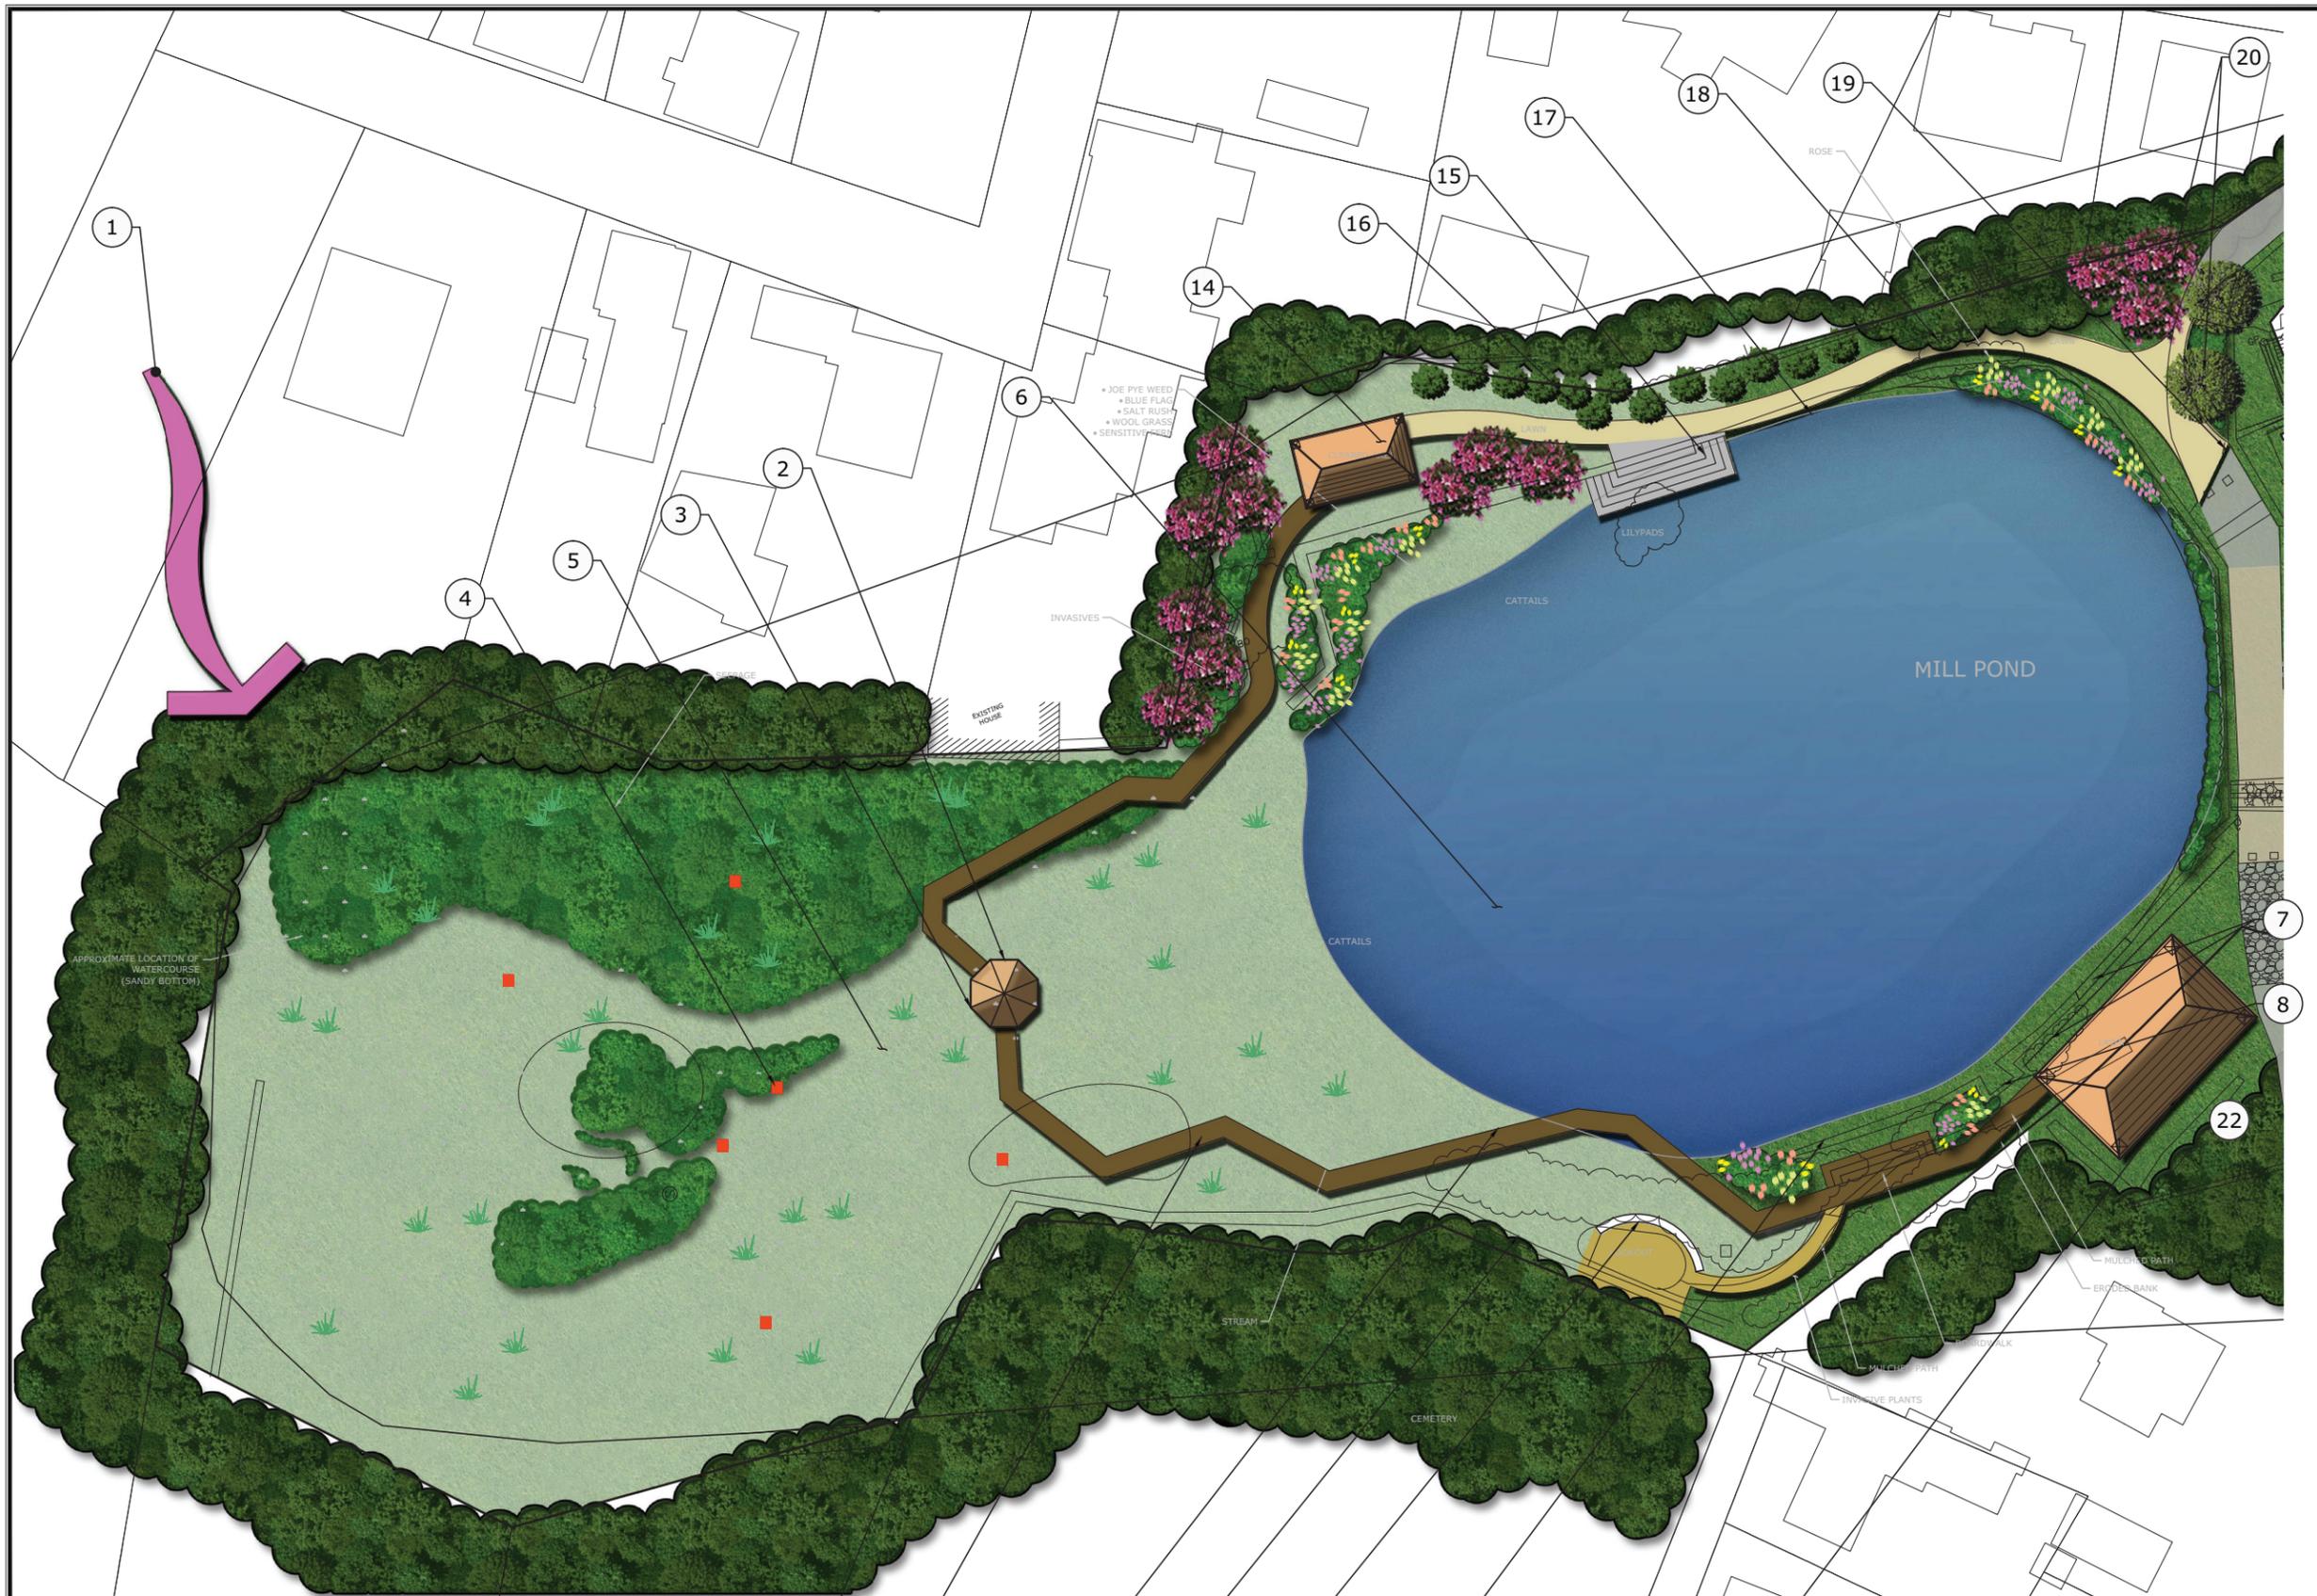
CONCEPT- 'B' (MILL POND)

4. Whimsical bird boxes placed within wetland area
5. Restoration plantings
6. Remove all of the cattails
7. Repair section of wall and add low guardrail
8. Maintain historic stairs

13. Granite edge to remain – repair as necessary
14. Icehouse pavilion and plaza space
15. Granite block steps/seating into pond
16. Evergreen screening
17. Rebuild granite block pond edge to accommodate seating

18. Granite chip walkway
19. Historical signage identifies prior site use
20. New trees and garden club plantings welcome visitors from King Street
21. Modify grades to accommodate temporary tent space. Granite cobble pavers with signage that illustrates this space’s historic use as an icehouse

22. Architecturally designed, open-aired pavilions should meld the coastal vernacular with the visual scale of post and beam barn

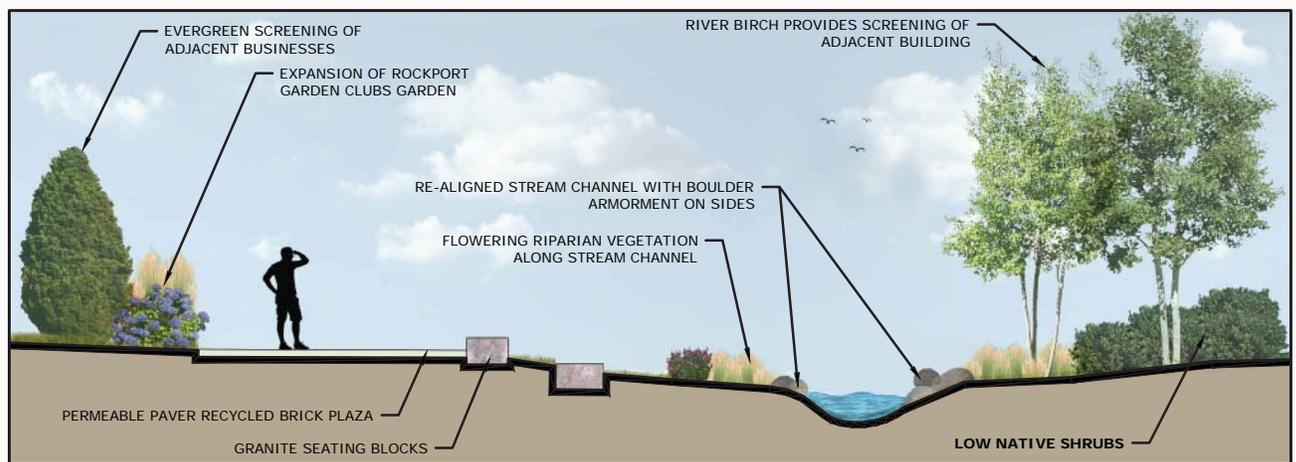
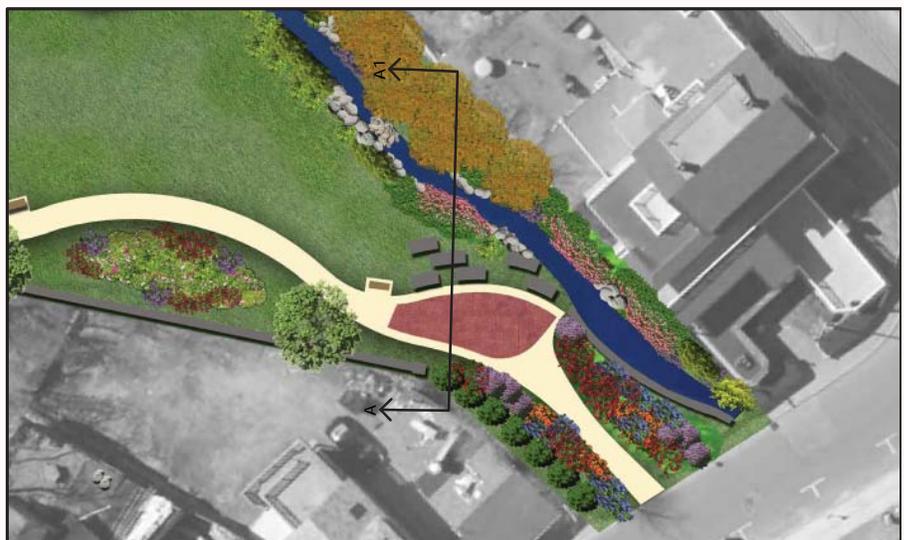
CROSS SECTION A - A1

E. Granite Terrace Seating

Expanding off of the Culvert Wing Wall (Item B.), place granite blocks on the slope to provide access to the stream channel. Granite blocks provide a great place for adults to sit and for children to gather and listen to stories in a small amphitheater-like setting. Coordinate with Town DPW to identify sources for local granite.

Replace the existing failing retaining wall with a new cast in place concrete wingwall with granite veneer, to alleviate the existing pinch point, and allow for greater water volume and velocities to enter the culvert.

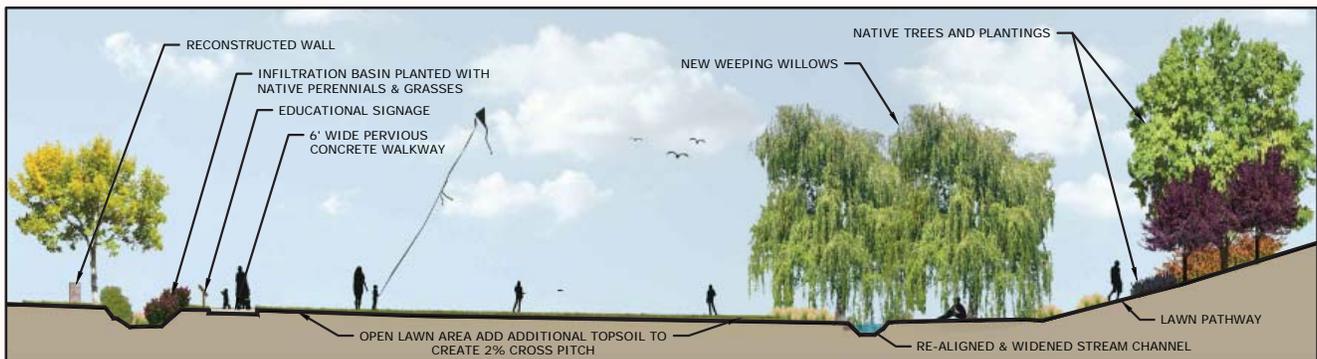
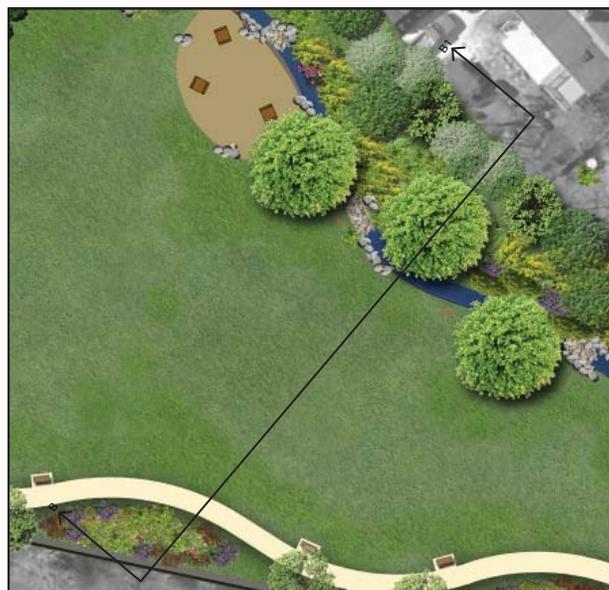
CROSS SECTION B - B1

P. Fieldstone Wall Reconstruction

Consider rebuilding the existing fieldstone wall along the southeastern edge of the site. Import additional fieldstones to raise the wall to 4 feet to help screen the adjacent asphalt parking lot. Columns on the ends of the walls help to delineate the entrances.

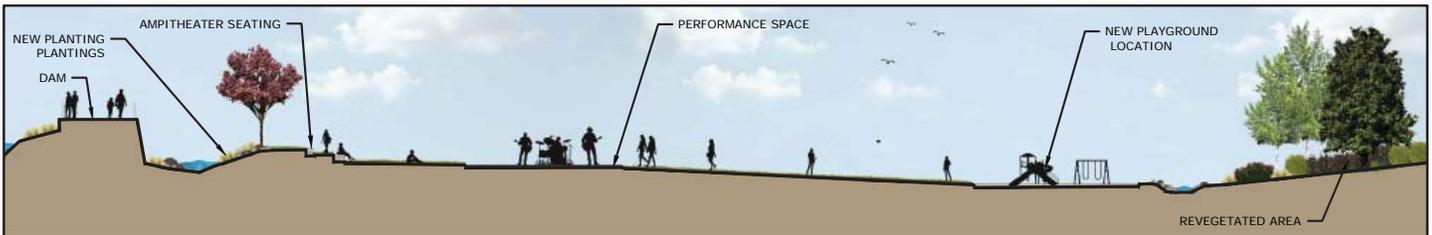
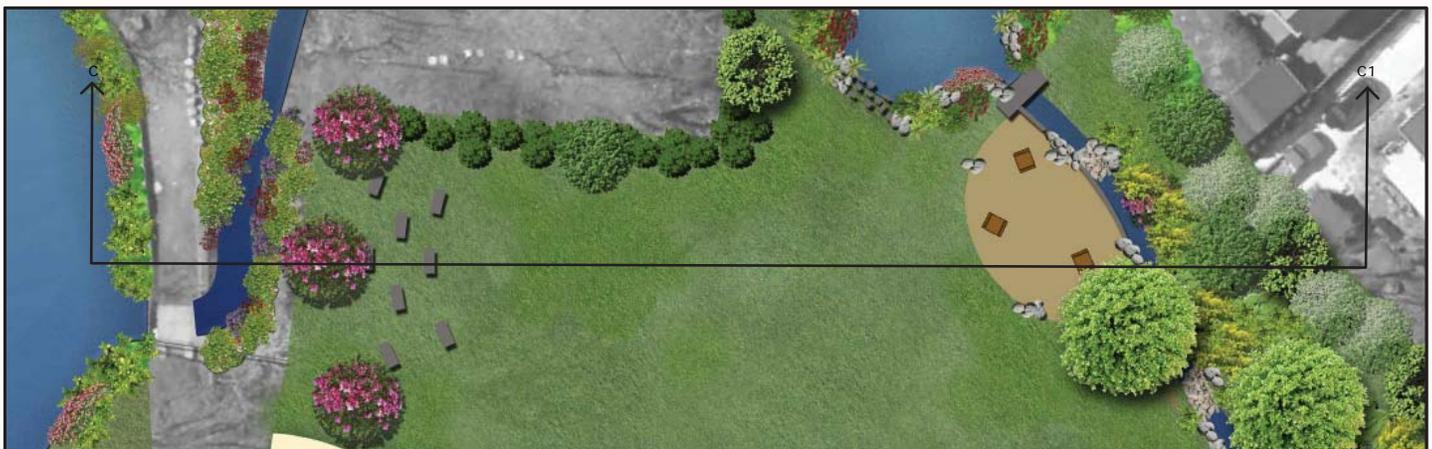
CROSS SECTION C - C1

Y. Children's Playscape

The swings and slide are not in compliance with current playground safety standards. The existing play equipment is dated, discolored, and lacks any aesthetic qualities. Relocate the play area to increase usable open lawn space in the meadow and install new a slide and swingset that meets current playground safety standards. Provide a vegetative barrier between the play area and the stream channel. Provide picnic tables adjacent to the playground and add baby swings to the swing set(s).

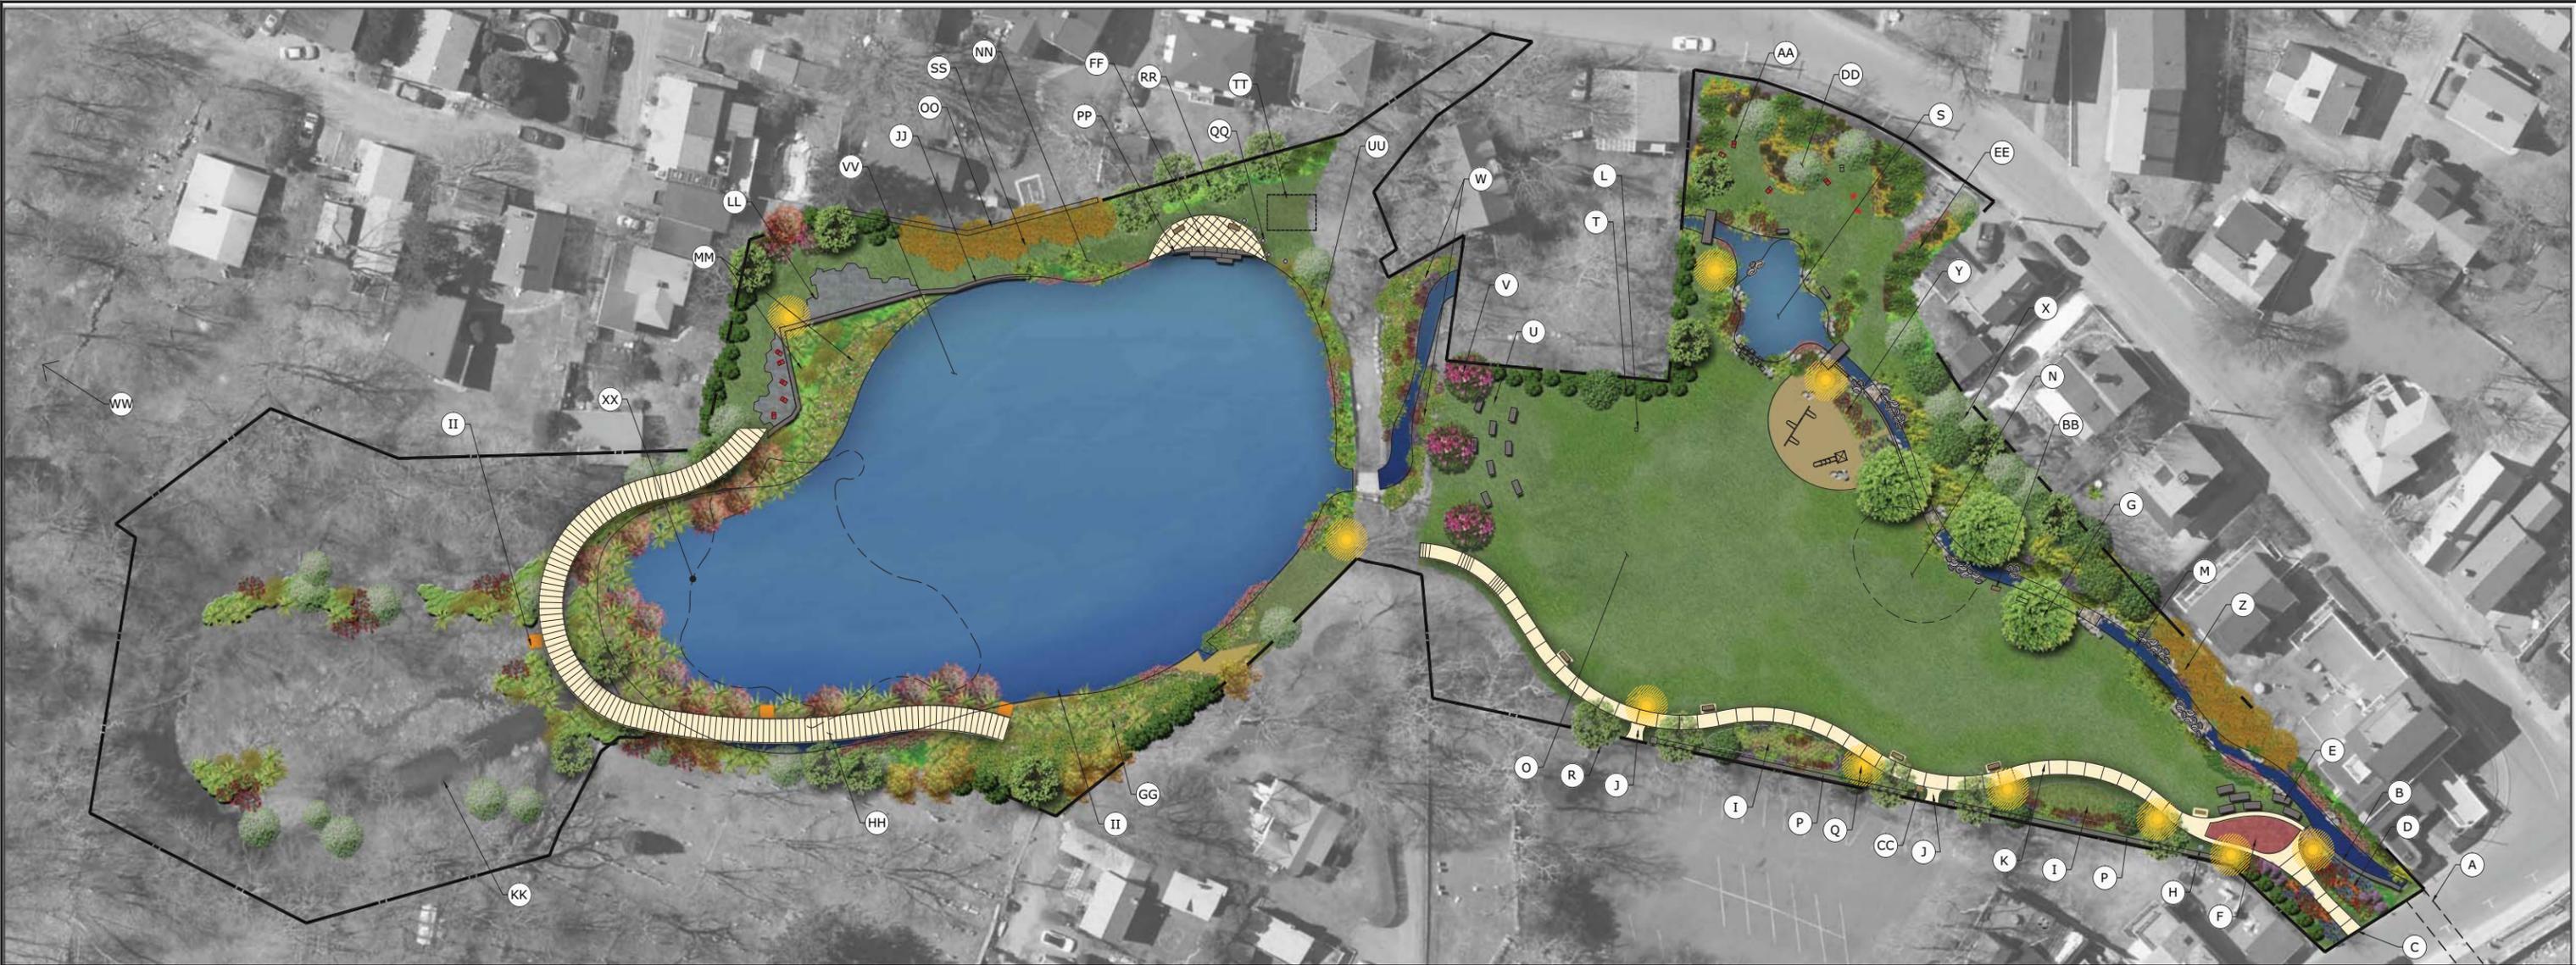
CONCEPTUAL MASTERPLAN
**MILLBROOK MEADOW AND
MILL POND RESTORATION**
ROCKPORT, MASSACHUSETTS DECEMBER 2014

After presenting the two conceptual plans, Milone & MacBroom, Inc., with the help of the Millbrook Meadow Advisory Committee, anonymously collected questions and comments through email, to better gauge the community's view of the proposed concepts. While many comments celebrated the potential improvements to the site, many comments reflected a concern that the improvements would change the character of the park and that "simple" is better. Taking this sentiment into account and the long history that people have had with the site, MMI working with the town and Millbrook Meadow Advisory Committee have compiled those elements that seemed to be favored by the majority of the public and have developed them into the Conceptual Master Plan.

Falling stones, utility pipes (some of which may be abandoned), and a curved longitudinal profile contribute to debris clogging inside and upstream of the culvert. As a Phase I approach, investigate cutting and capping any utilities and resetting/repointing stones within the culvert. If clogging is still an issue, consider investigation of full culvert replacement.

To alleviate direct flooding of the meadow from the adjacent parking lot, install two stormwater infiltration gardens to catch and filter stormwater overflow. The depressional infiltration/rain gardens are to be planted with native flowering perennials and grasses. Place artist designed colorful bird boxes on posts in the garden. Excavation and permitting of the infiltration gardens will require soil sampling to understand infiltration rates, groundwater elevation, and potential contamination issues. If presence of groundwater is discovered at an elevation that inhibits to construction of the infiltration gardens, consider constructing lawn seating mounds that screen the adjacent parking lot and provide a seating element to relax and view the meadow.

Restore accessibility, open water, and enhance aesthetic value of the pond. Frog Pond is being choked by aggressive emergent wetland vegetation due to sedimentation and shallow water depths within the pond. By the end of summer, the pond does not have much open water present and is dominated by broad leaved cattail. Public accessibility to open water is limited. In order to restore the open water to the pond, it is recommended that the pond be dredged by mechanical methods (i.e., conventional excavation equipment) to an approximate open water depth of 4 feet. Removal of the emergent wetland vegetation is required. The granite blocks that help stabilize the shoreline of the pond shall remain in place and shall be reset as necessary. Construction of granite steps should be installed along the bank to allow for better accessibility to the pond and allow for seating during the low-flow periods of the year. In addition, it is recommended that natural boulders be added to the shoreline to provide a more natural feel and provide frog and turtle sunning areas. Shrubby and tree sapling vegetation that surrounds the pond should be removed to allow for a new riparian zone planting area with a mix of native woodland shrubs and perennials. The planting of a limited number of low-growing emergent wetland vegetation is recommended for the immediate pond edge including species such as duck potato, soft stem bulrush, and/or pickerelweed.

Boardwalks allow people to enter and learn about environments they normally wouldn't have access to. The Mill Pond Winding Boardwalk takes pedestrians along the water's edge and over it to explore views of the rear wetland ecology as well as providing views north across the pond, a view probably never seen before by many Rockporters. The boardwalk also creates a loop around the Mill Pond for uninterrupted walking access on the upper portion of the site.

Dredge Mill Pond to restore open water for fishery habitat and recreational use, enhance aesthetic values of the pond, stabilize shoreline and enhance littoral habitats, and manage invasive riparian zone vegetation. In order to restore and enlarge the open water areas within the pond to more historic conditions, it is recommended that the pond be dredged by either mechanical and/or hydraulic methods. The cattail-dominated delta should be removed to provide more open water habitat to fish and more recreational area for fishing and ice skating. The pond's depth should be lowered to approximately 8 to 9 feet, which would help decrease water temperatures and increase dissolved oxygen levels within the pond to better support a warm-water fishery resource. In addition, the deeper water depths would help limit the growth of submerged aquatic and floating aquatic vegetation within the pond. Grading along the northern edges of the boardwalk feature will be designed to create shallow littoral planting shelves to assist in screening views of the boardwalk when viewed from the dam.

Area of existing cattail vegetation to be removed during dredging operation.

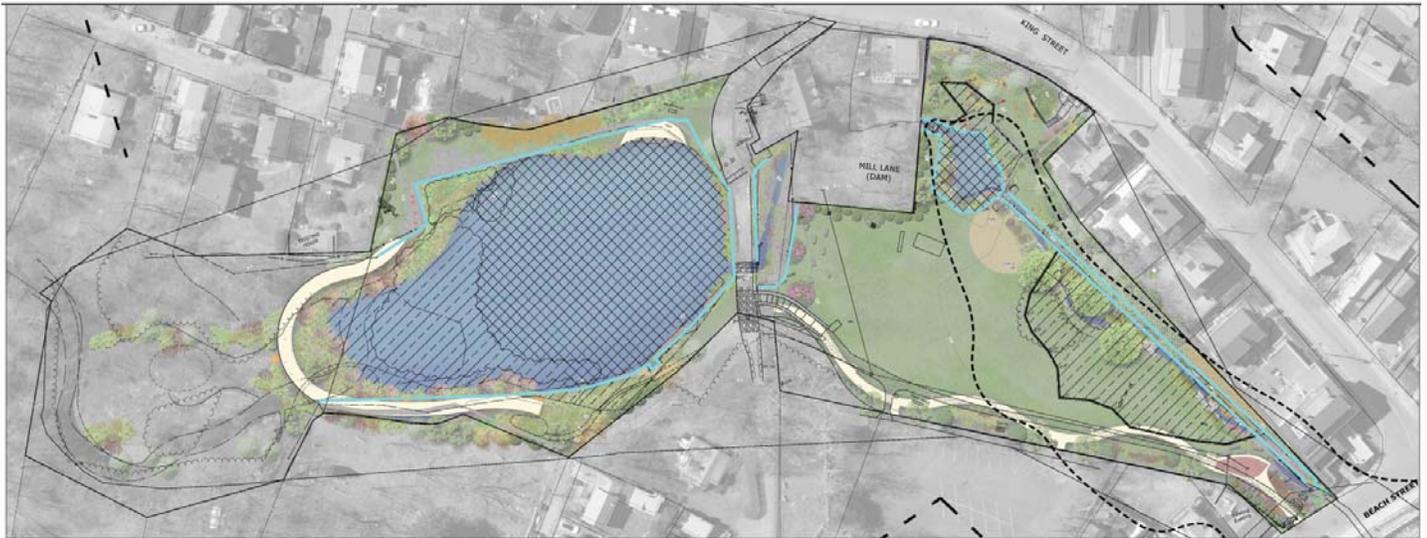
REGULATED RESOURCE AREA IMPACTS LEGEND

±24,639 SQ. FT.
